Transportation
Safety Board
of Canada

Our reference
A19A0062-D1-L1

Subject: **Air Safety Information Letter A19A0062-D1-L1**
Aileron Control System Geometry/Rod End Bearings

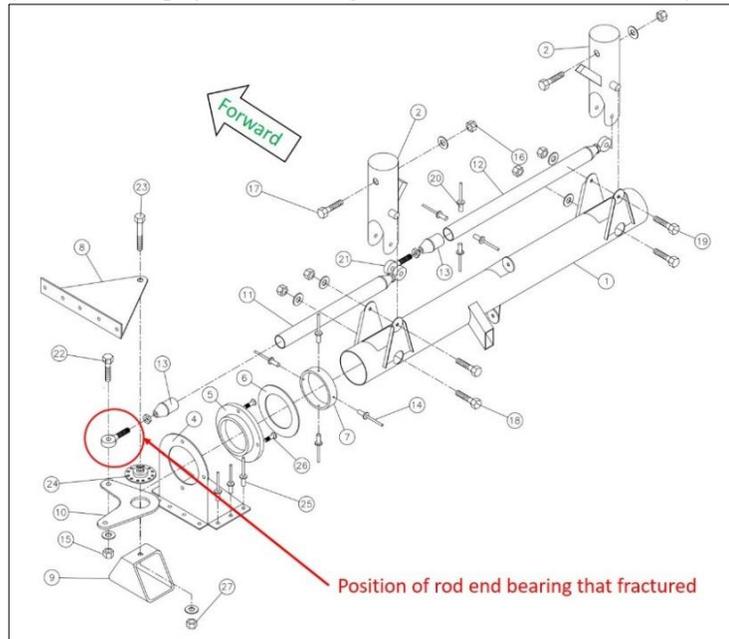
Figure 1. Exploded view of the Murphy Rebel control column (Source: Murphy Aircraft Mfg. Ltd, with TSB annotations)

The rod end bearing that fractured was threaded into the outboard end of a push tube assembly (item 11, Figure 1) that is fabricated by the aircraft kit builder. This push tube assembly transfers aileron control input to the bell crank (item 10, Figure 1) mounted on the left, outboard side of the control column assembly.

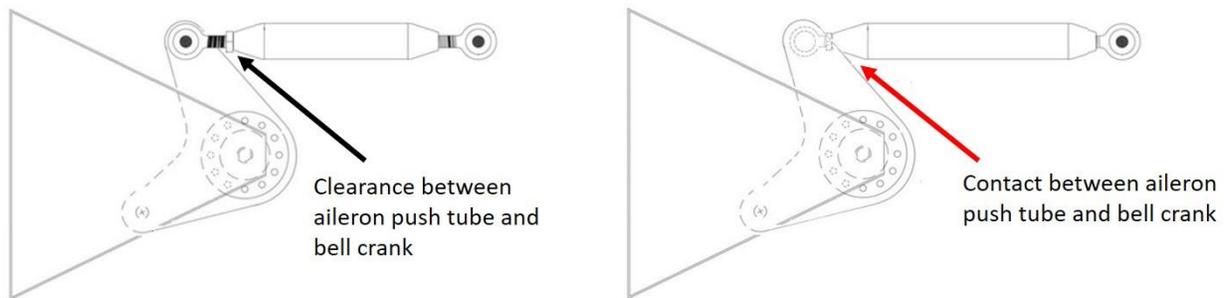
The Murphy kit instructions state that the tube material used to assemble the push tube must be cut to 3 inches in length; however, the tube material used to assemble the push tube submitted to the TSB had been cut to 4 inches in length. Therefore, the assembled push tube was longer than that specified in the instructions. As a result, the rod ends had to be threaded in further to achieve the aileron control system rigging (Figure 2).

Figure 2. The image on the left shows the aileron push tube and bell crank during full aileron control deflection, and when assembled as per the manufacturer’s instruction. The image on the right shows the same deflection, but with rod ends assembled as per the occurrence aircraft. (Source: TSB, based on information from Murphy Aircraft Mfg. Ltd).

The occurrence rod end bearing had been threaded completely into the aileron push tube assembly, which resulted in the jam nut contacting the bell crank when the push tube was moved outboard during full range aileron control inputs in that direction. In addition, the push tube rod end bearing had been mounted on the underside of the bell crank. This position was contrary to the manufacturer’s drawing, which shows the push tube rod mounted on top of the bell crank.

The rod end bearing fractured at the last root, outboard of the jam nut, due to the combination of the misalignment and the transverse forces encountered from this interference contact. In normal operation, the rod end bearing is loaded only along the push tube longitudinal axis.

Deviation from Murphy Rebel kit assembly or rigging instructions can cause an aileron control geometry issue that may result in insufficient clearance between the bell crank and the jam nut, which could make the aircraft difficult to control as a result of jamming or rod end failure. In addition, using part number HM-4M rod end bearings instead of part number MM-4M rod end bearings may result in an installation that is more tolerant to occasional side or transverse loading situations.
